How a Catastrophic Flood of the Gürbe River Triggered the Rethinking of Local Flood Protection

Melanie Salvisberg

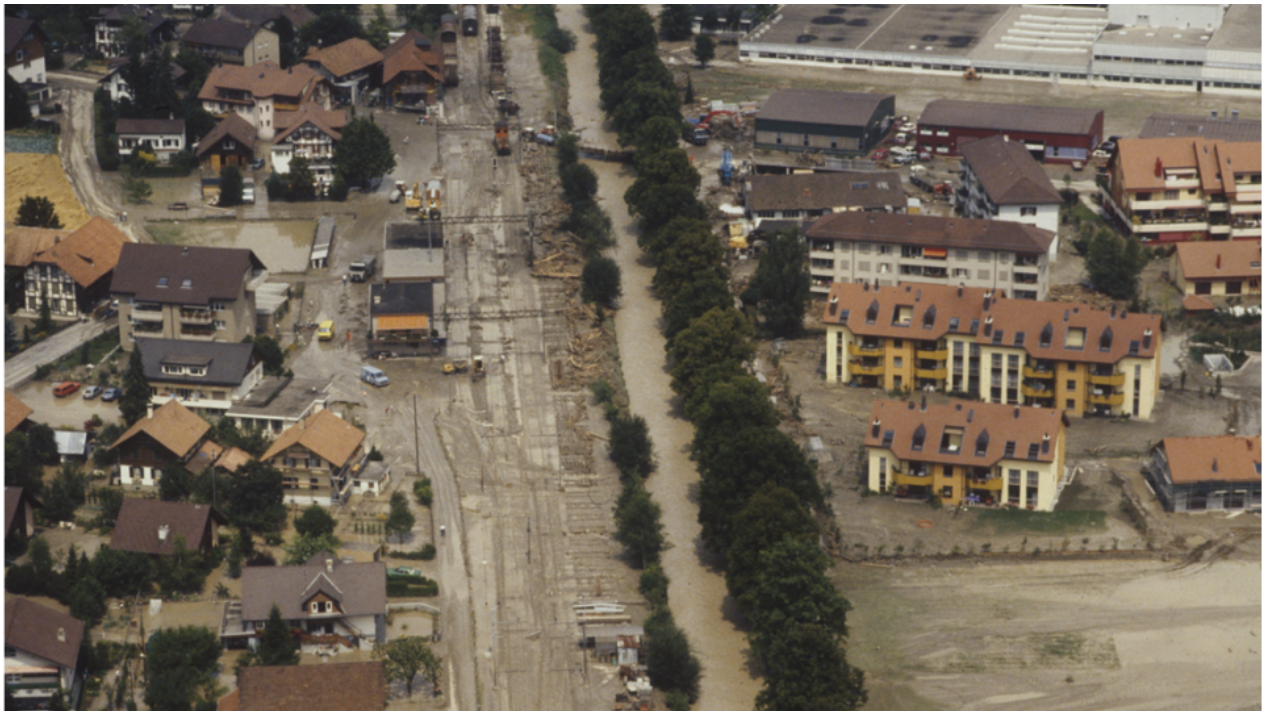
Flooded settlement in Toffen after the event of 29 July 1990.

On the evening of 29 July 1990, after a warm and sunny day, the sky over the Gantrisch region in the Swiss pre-Alps suddenly darkened. A huge thunderstorm appeared—a thunderstorm that not only set a meteorological record, but also changed the approach to flood protection in the Gürbe River area profoundly. Within a short period, the water level rose rapidly, causing the 29-kilometer-long river, a tributary that joins the Aare River south of Bern, to overflow. The water and the bed load caused severe damage to hydraulic structures, farmland, settlements, and traffic facilities near the river. The total cost of the damage was estimated to be 40 million Swiss francs.

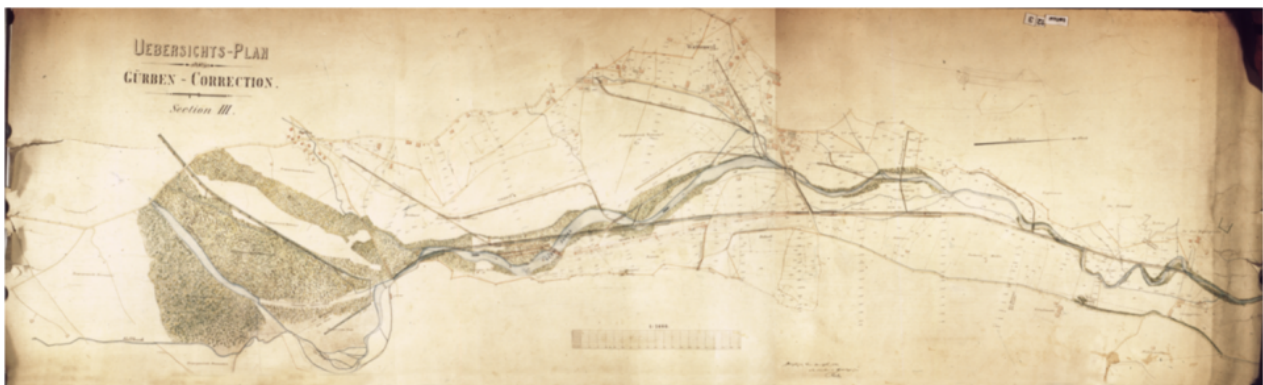
Plan of the natural course of the Gürbe River and the planned channel in Wattenwil, 1881.

Although the Gürbe Valley was known to be flood-prone, due to frequent thunderstorms, steep slopes, soil with low water-storage capacity, and soft rock in the upper reaches, the extent of the event was a shock, especially because extensive measures had been taken to prevent inundations since the mid-nineteenth century. The efforts had started with alterations to the Gürbe River from 1855 to 1881. With the intent of protecting the Gürbe Valley from flooding but also of reclaiming new land from the swampy flood plain, the previously meandering

river was straightened and channelized in its flat lower course. In the steep upper reaches, numerous workers erected dozens of wooden and stone dams to control discharge and sediment transport. Dikes to deflect the flow of debris, drainage systems, and slope stabilizations completed the torrent control.

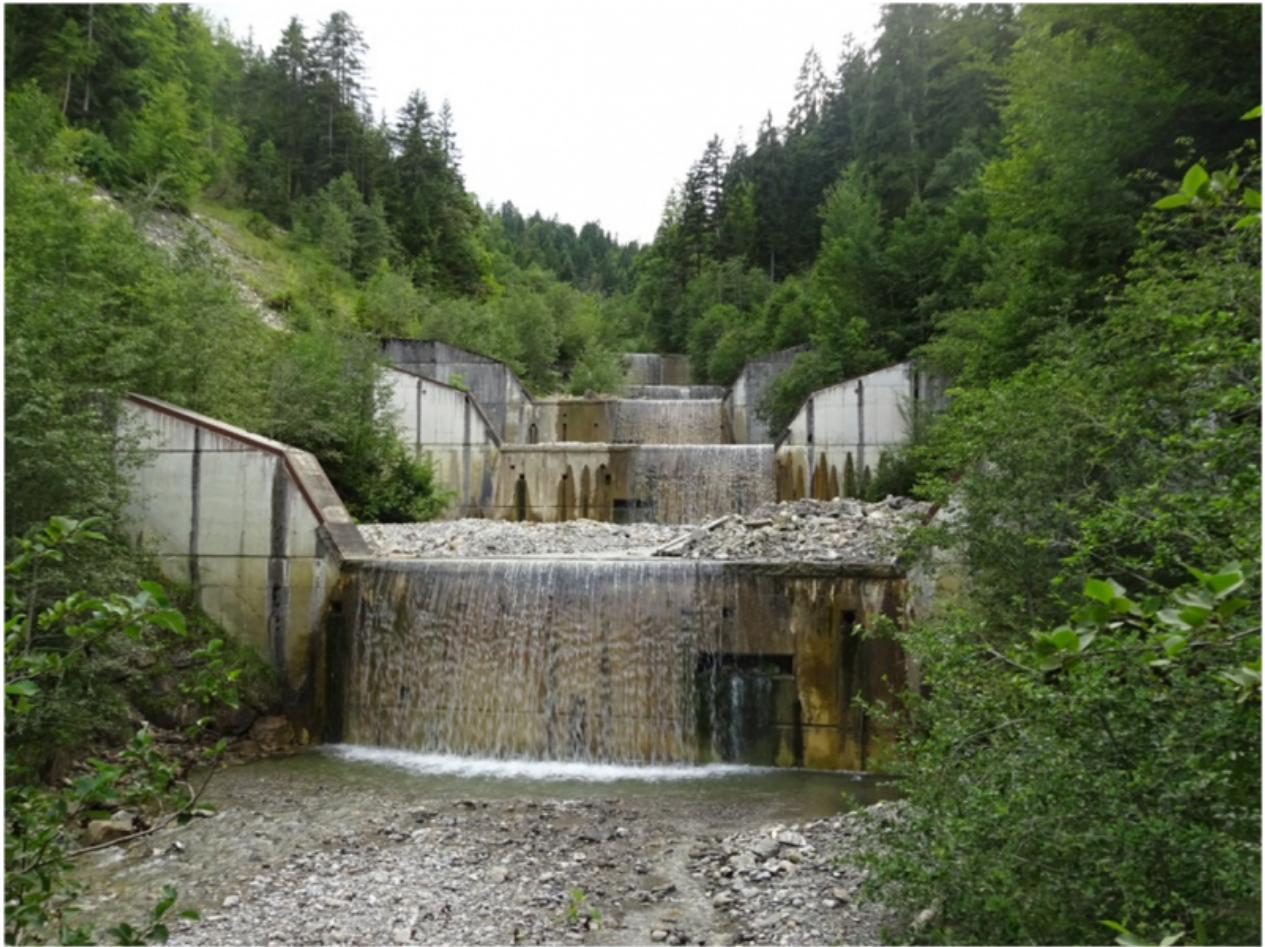
Torrent check dams in the gorge of the Gürbe River.

Although the measures ameliorated the flooding situation, the goal of completely preventing inundations was not achieved. Again and again, landslides and floods led to damage. The hydraulic structures were therefore renewed and expanded in numerous consecutive projects. The main focus lay on the upper reaches, where the workers built larger and additional transverse structures (made from concrete since the early 1900s) and completed the slope stabilizations. Similar structures were built in the tributaries. On the valley floor, the channel was extended and widened. In addition to the hydraulic structures, hundreds of hectares of alpine meadow were reforested in the river's catchment area, despite resistance from landowners. In the beginning of the twentieth century, the Gürbe River was embanked and consolidated from its mouth to its source.

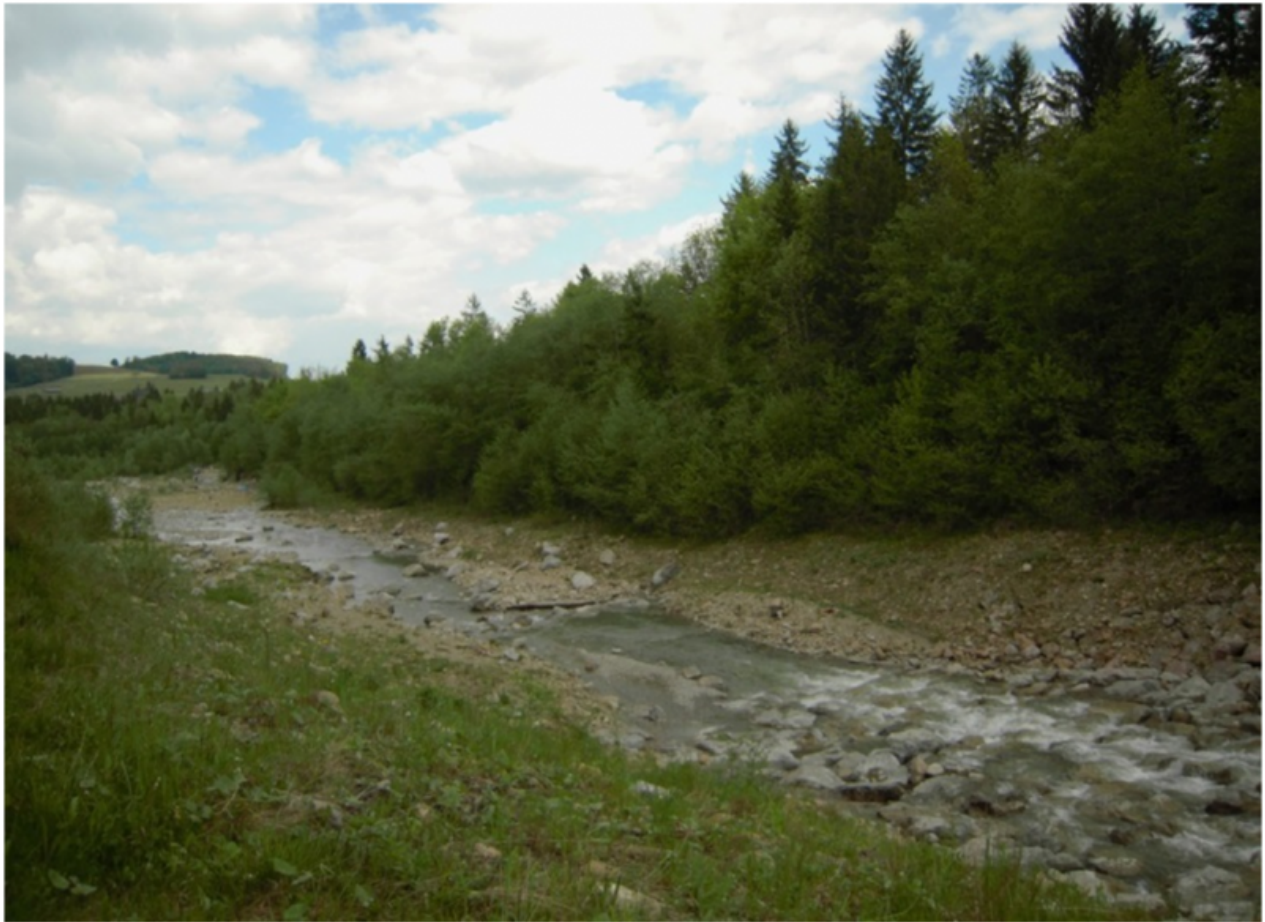
Partly restored stretch of the Gürbe River on the alluvial fan today.

As with many other Swiss rivers, the renaturation of the Gürbe River was only partially feasible due to the intense use of the riverine zone. Larger revitalized stretches could, however, be developed in the area of the river mouth and on the alluvial fan. For the valley floor, the hydraulic engineers planned retention areas.
